Pearl Harbor Wetlands Inventory

Wil Chee Planning, Inc.
1018 Palm Dr.
Honolulu, Hawai'i 96814

AECOS, Inc.
45-939 Kamehameha Hwy, Suite 104
Kāne'ōhe, Hawai'i 96744-3221

November 30, 2007

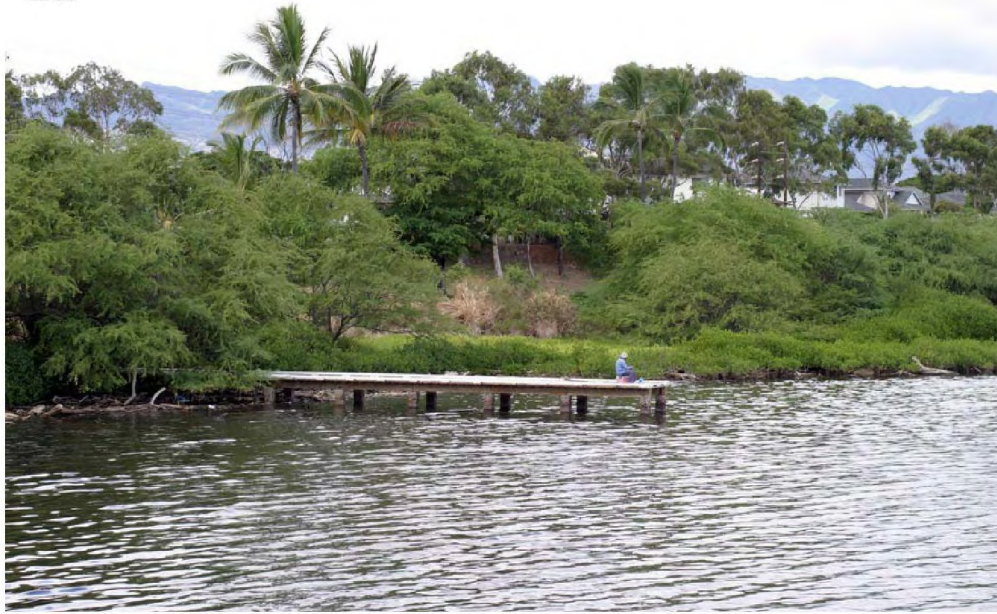
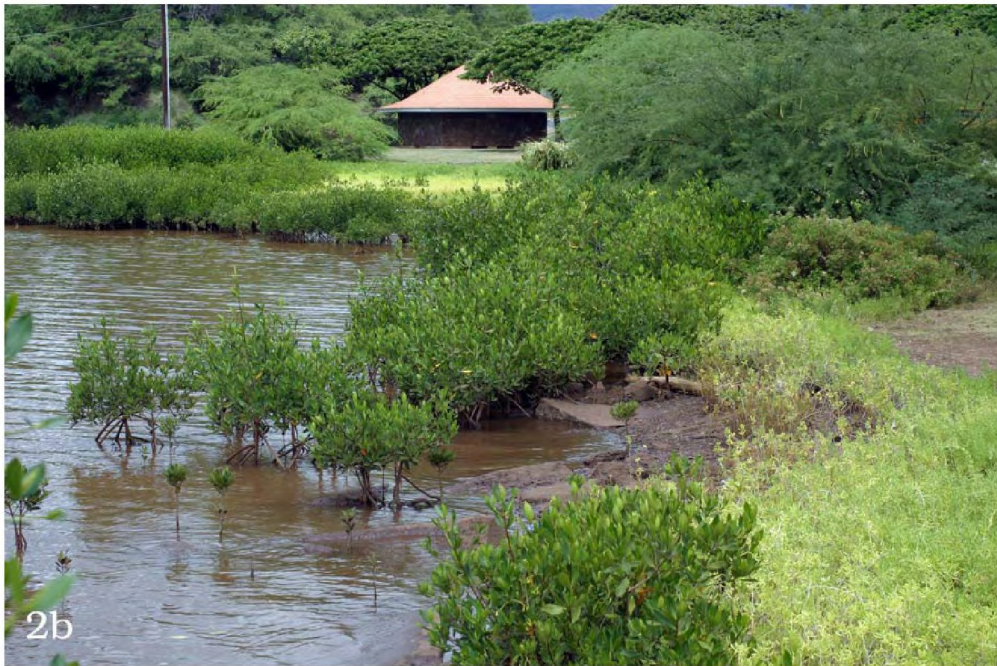
2a

Figure 2: a) North side of peninsula at West Loch Community Park showing upland vegetation reaching to the exposed, basalt rock shore (no wetlands are present here). b) South side of peninsula showing mixed 'akulikuli kai/red mangrove wetland across a gently sloped shore.

The difference in nature of the shore and subsequent wetland development is clearly illustrated by the peninsula at West Loch Shoreline Park. This feature is a finger of lava rock that extends into West Loch. The dominant Trade winds, blowing from the northeast to east, set-up waves across the upper end of West Loch that erode the north shore of the peninsula (Fig. 2a). The south-facing shore is more sheltered and consequently, depositional. The gradual transition to deeper water across a shallow, low-sloping tidal flat or beach is one quite suitable for emergent plants tolerant of the salinity regime. Consequently, the south shore is one of wetlands vegetated either by 'akulikuli kai or mangrove (Fig. 2b).

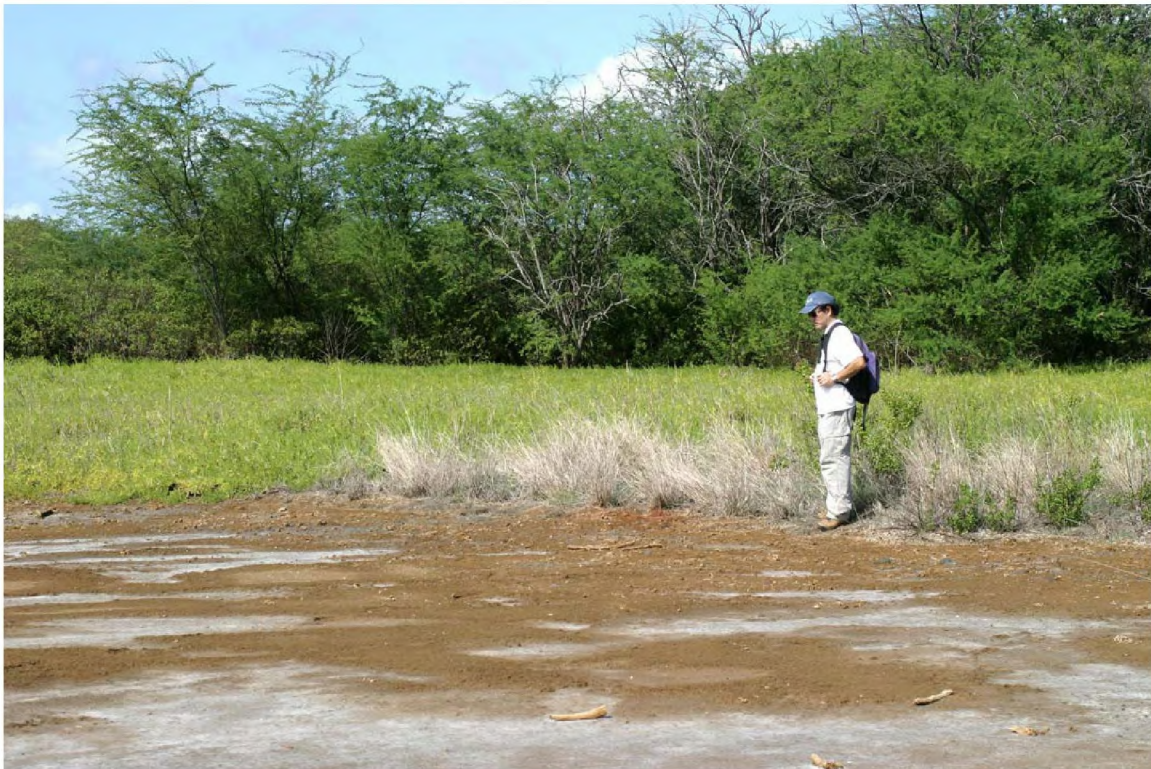
Figure 3. Playa formation beside the old Pearl City WWTP. Salt encrusted, bare soil in foreground is depressed relative to the flat behind overgrown with pickleweed, but the soil too salty to support even pickleweed.

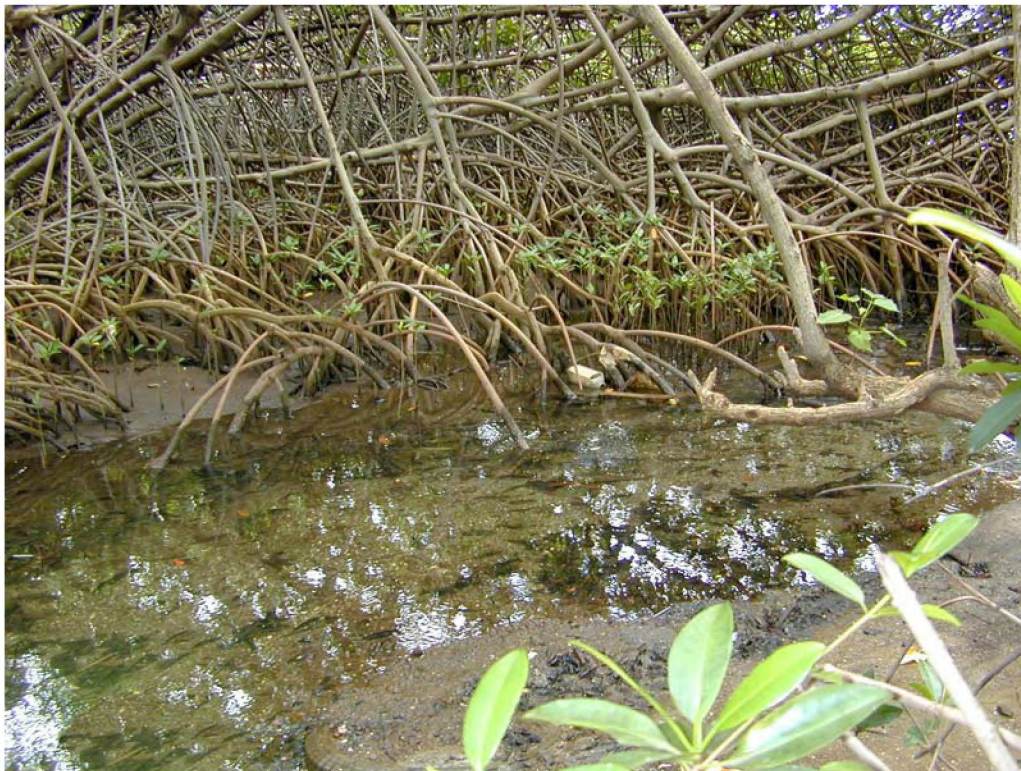
Figure 4. Red mangrove growing along a creek in Wai'au. This view from beneath the canopy shows the extensive prop-root growth of youthful trees. Note numerous mangrove seedlings on opposite bank.

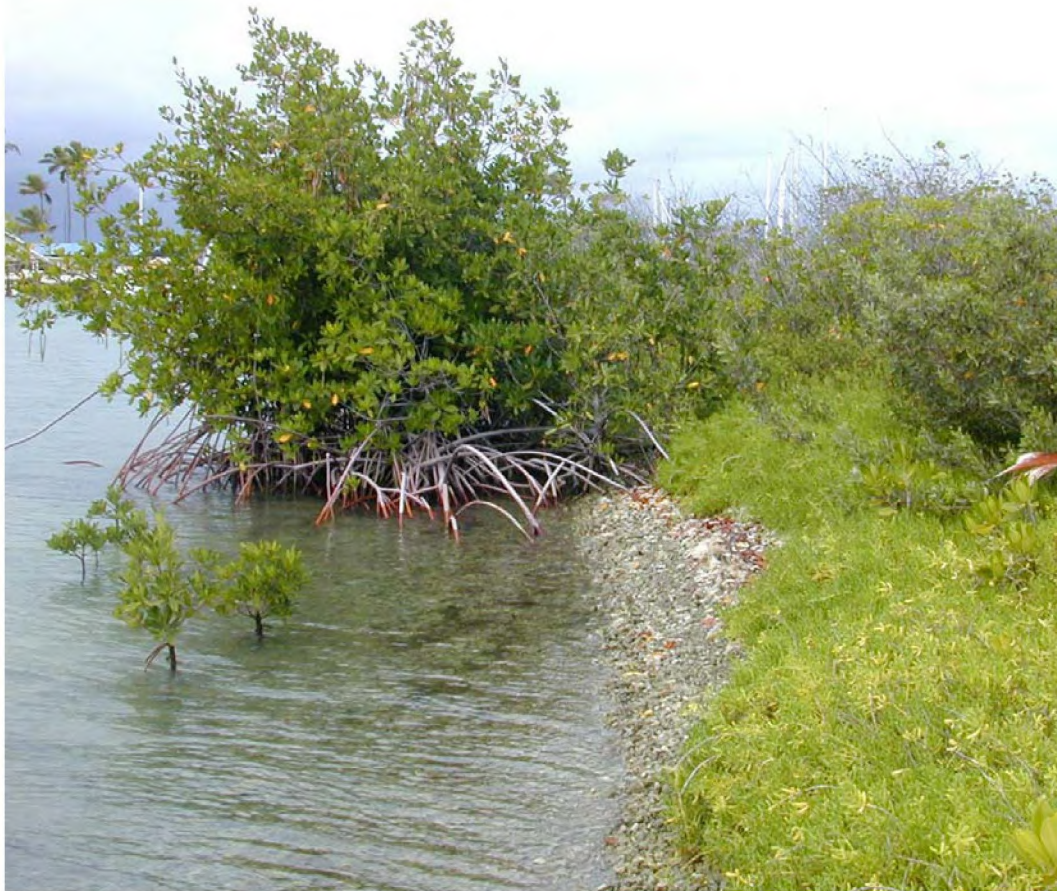
Figure 5. Red mangrove establishing on a gravel beach shoreline presently occupied above by pickleweed that will, over time, be overgrown or isolated behind a mangal (AECOS, 2006).

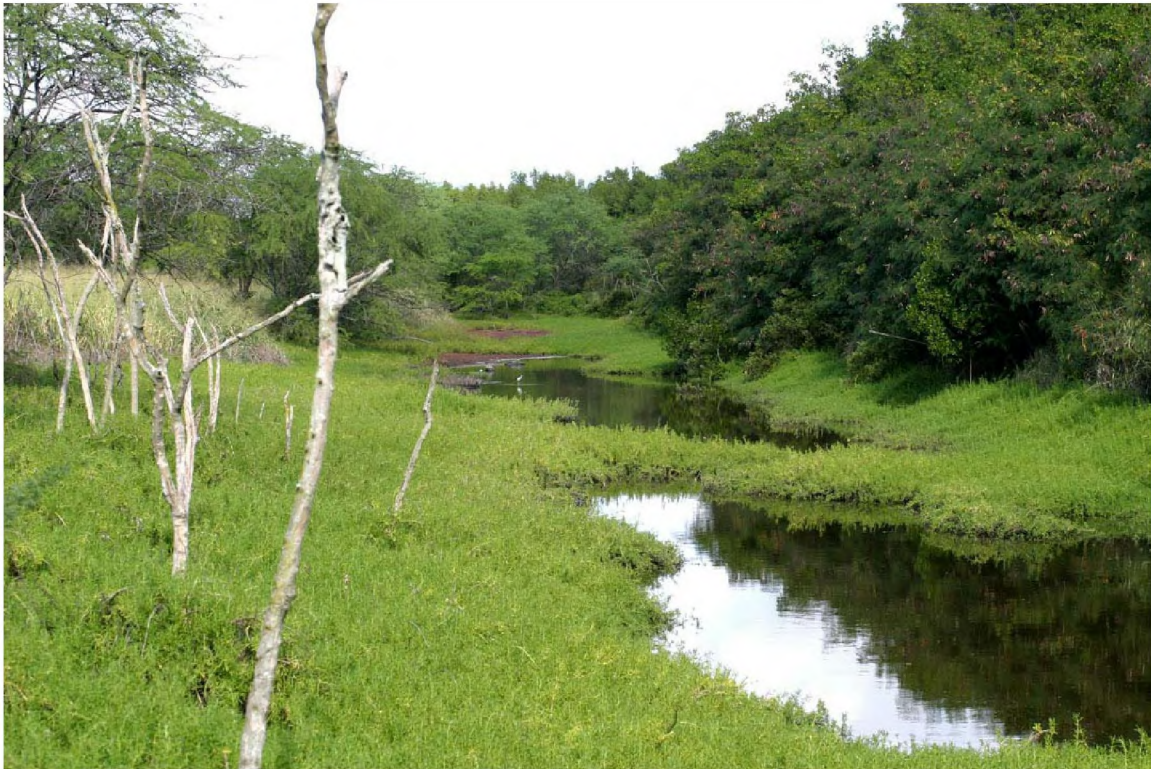
Figure 6. Pickleweed dominating a saline channel on the Pearl City Peninsula near the old Pearl City WWTP.

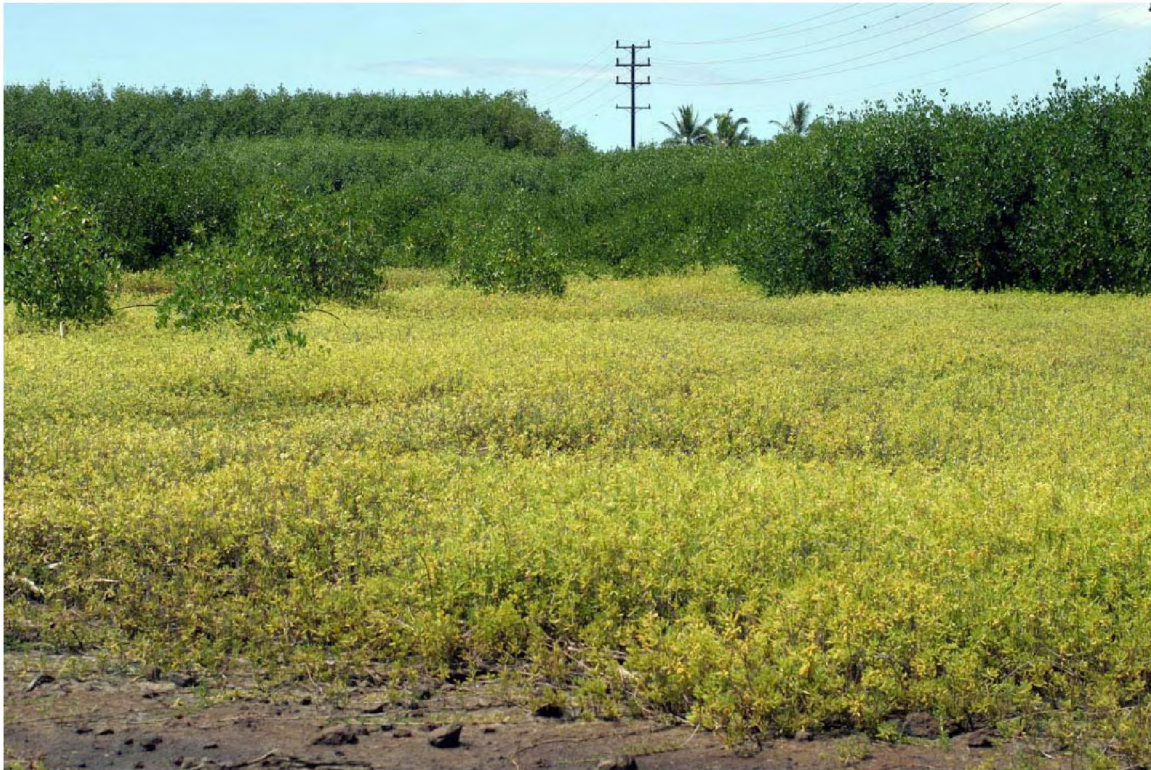
Figure 7. An interior area of pickleweed, south of West Loch Community Park, being slowly invaded by American mangrove (scattered shrubs on left and solid tree growth on right and background).

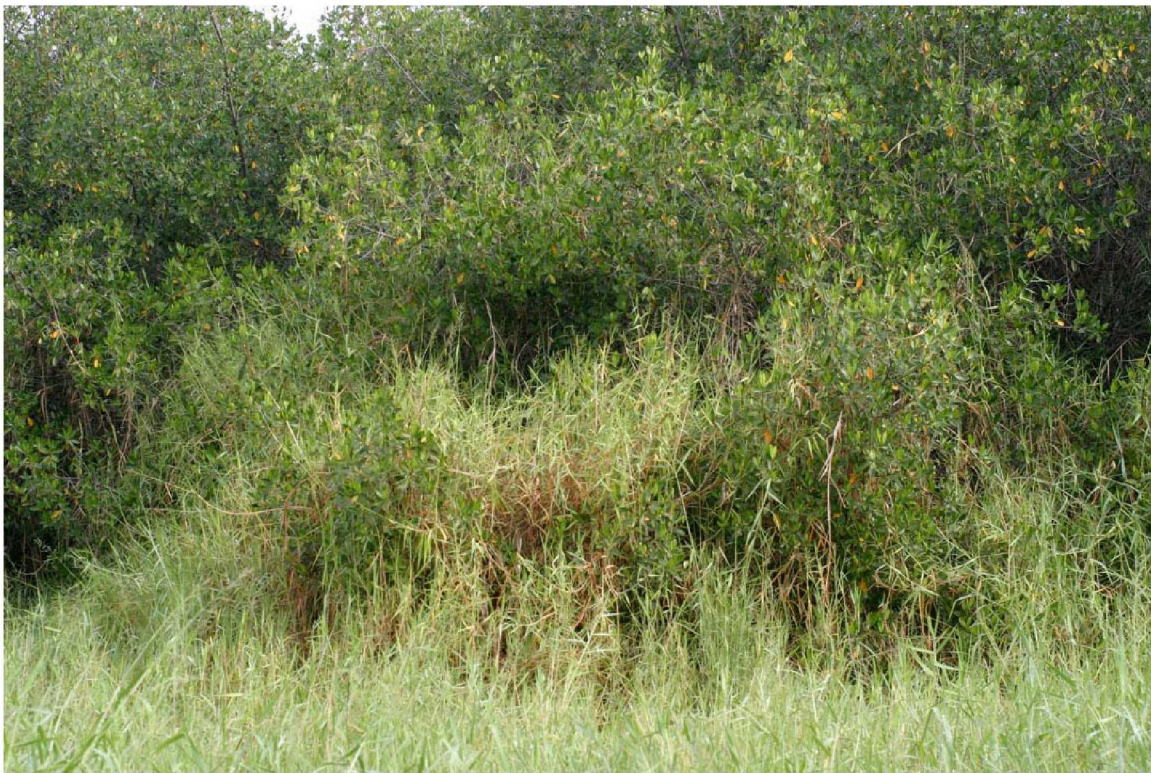
Figure 8. A somewhat unusual situation of a palustrine wetland dominated by California grass (foreground), the grass growing up into red mangrove at a palustrine/estuarine boundary.

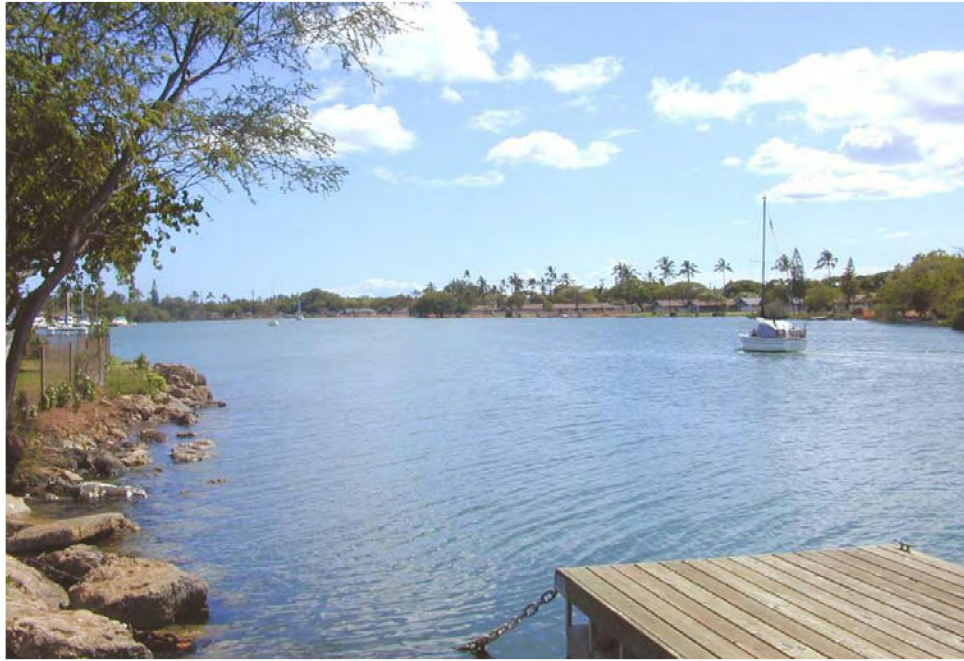
Figure 1-01. The outer lagoon at Iroquois Point Housing is a yacht basin. The shoreline is a man-made revetment of boulders.

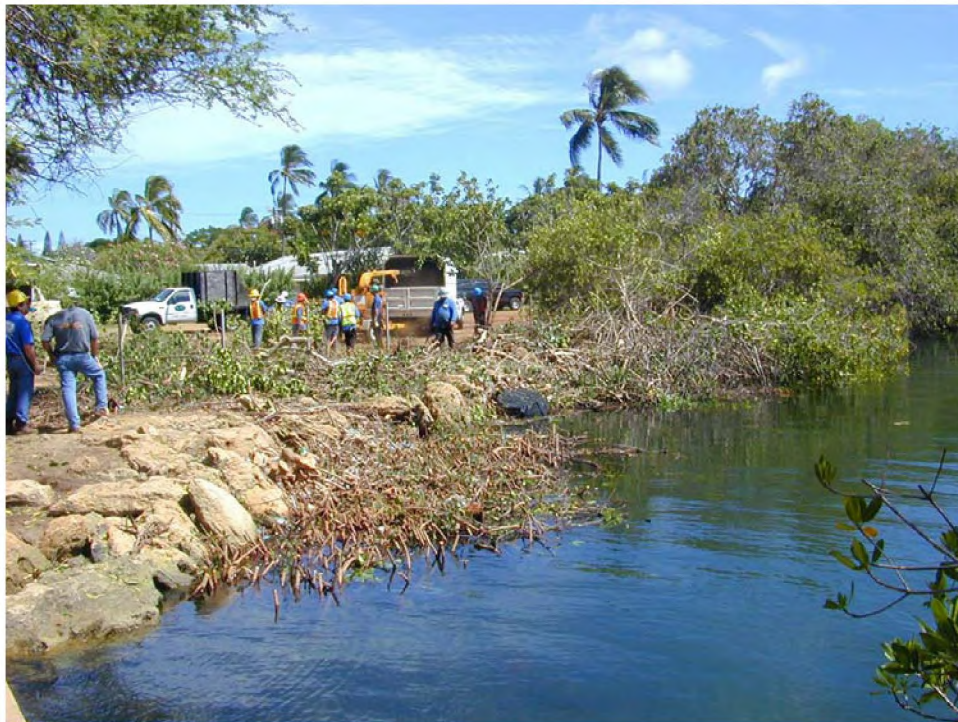
Figure 1-02. Removal of mangroves underway along shore of the inner lagoon at Iroquois Point Housing in June 2004. Trees were cut by hand in the water, then lifted out with a crane on the shore. Original shoreline here is placed (mostly limestone) boulders (see Fig. SP1-01).

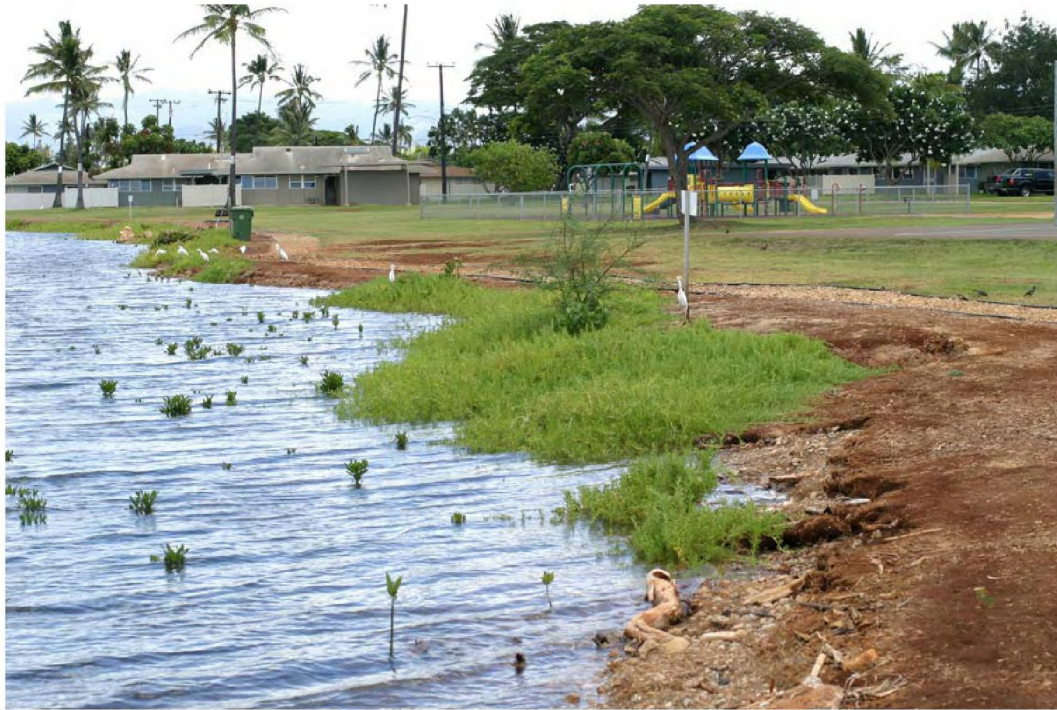
Figure 1-03. The shore of the inner lagoon near the community center. In some areas the shore is not armored and the fill is eroding. The resulting broad intertidal and subtidal shallows encourages aquatic plants such as pickleweed and mangrove seedlings as seen here.

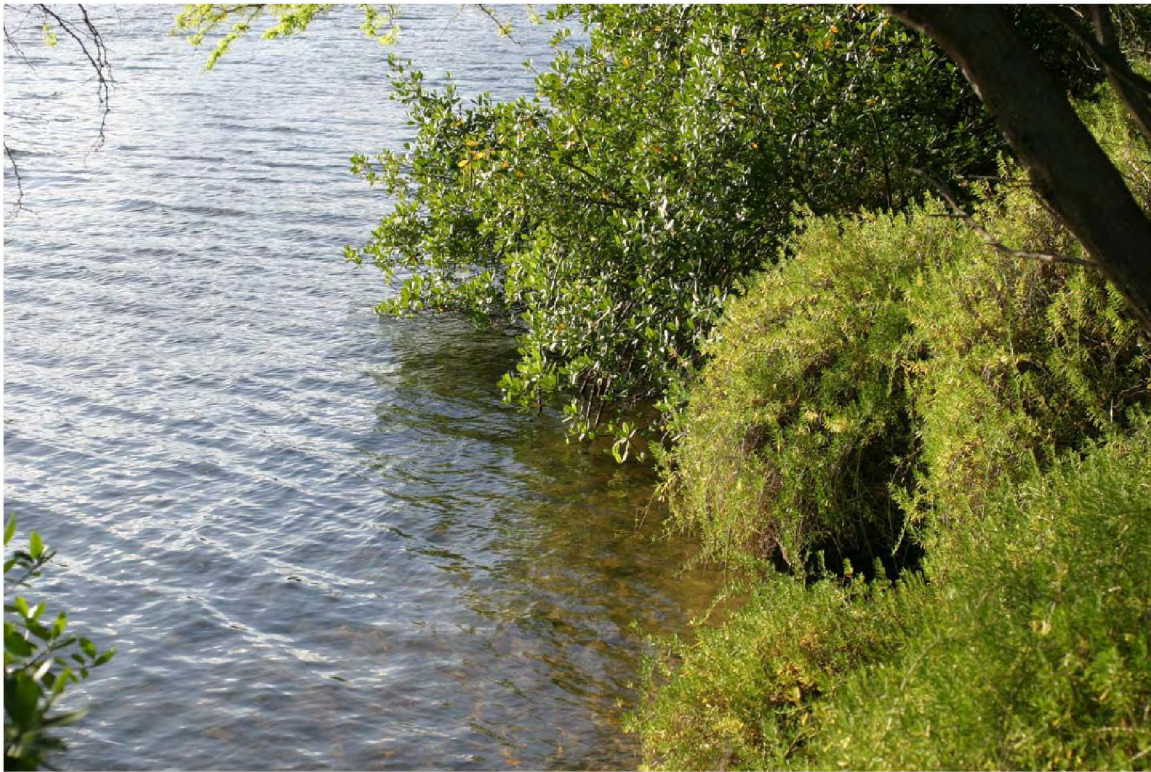
Figure 1-04. Cliff shoreline section (here only 2-3 m high) near Nichols Point, NAVMAGPH. Pickleweed on right covers a cliff face, while young mangroves cling to rocks at base of cliff and *kiawe* trees overhang this non-wetland shore (see also photo SP1-06).

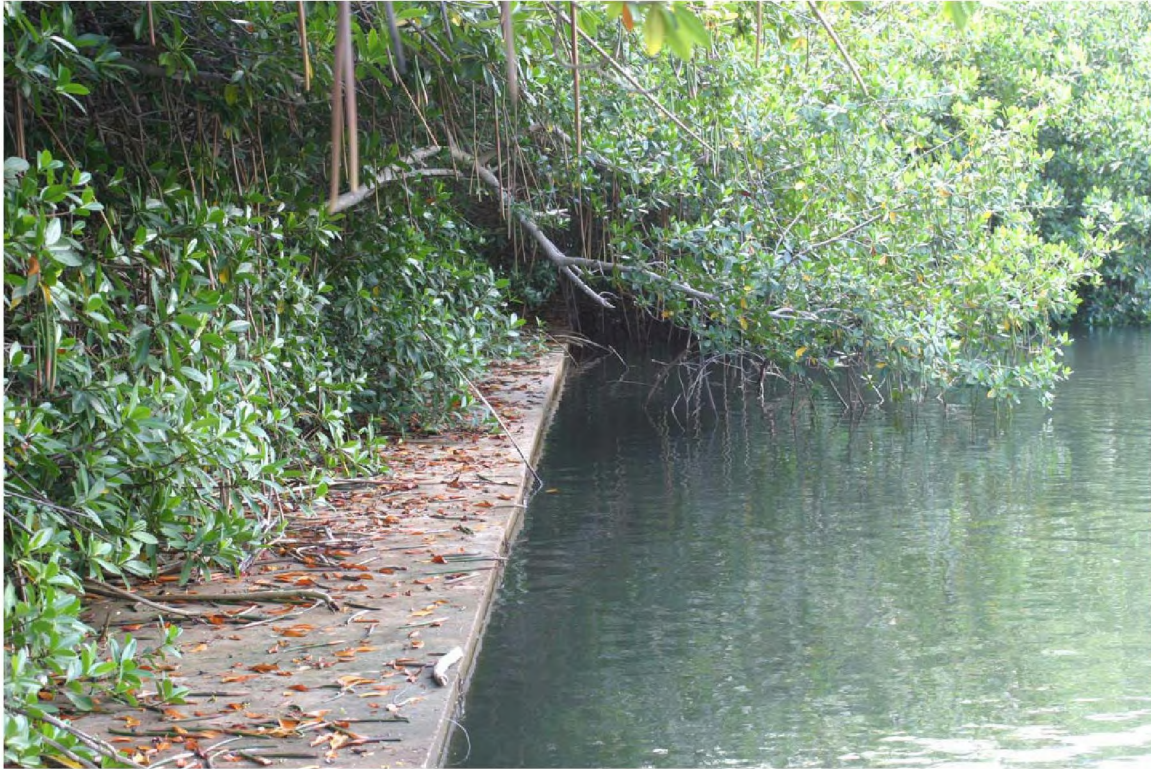
Figure 1-06. Portion of the south wall of an enclosed swimming area at Nichols Point. Mangroves are destroying this potentially significant historical feature.

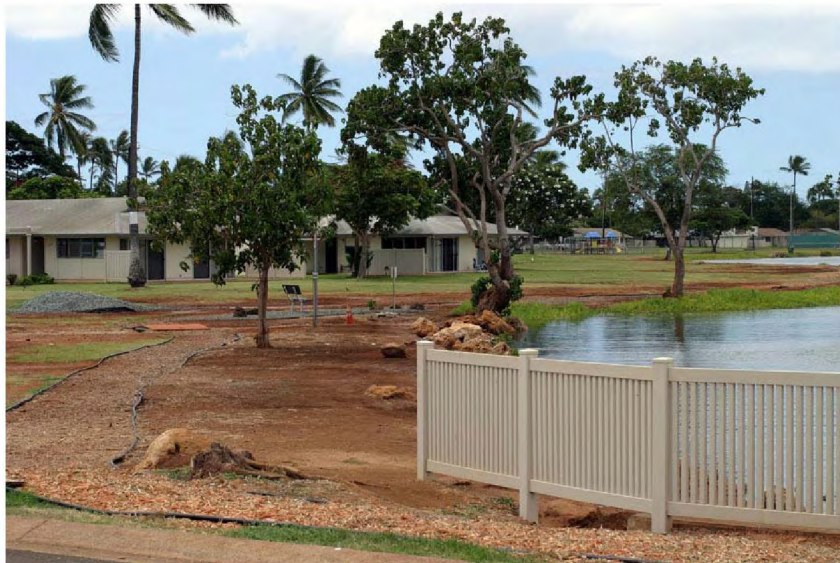
SP1-01 (right): area of removed mangrove trees at Iroquois Point Housing (same location as shown in Fig. 1-02), with community improvements underway in September 2006).

In 2004, permission was obtained from the ACOE for Hunt Building Company, Ltd. to remove the mangroves from the area (Fig. 1-02). In areas of dense mangrove growth, the trees had essentially isolated the housing units from use of the lagoon (e.g., the inner lagoon was not even visible from adjacent housing

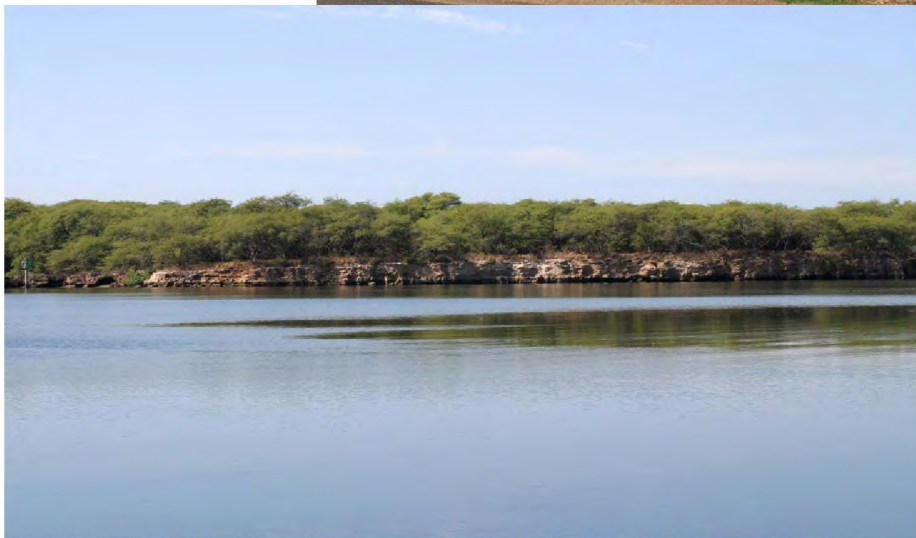
SP1-02 (left): typical NAVMAGPH cliffed shoreline with a forest of *kiaue* (*Prosopis pallida*) growing above the cliff line.

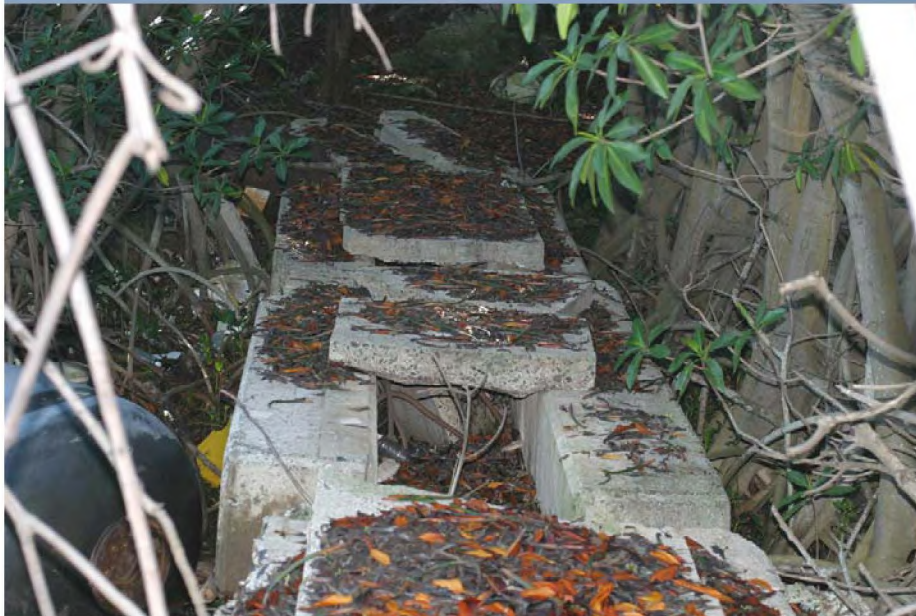
SP1-03 (left): wall structure across front of southern end of a pond at Nichols Point. Feature is deep inside a mangrove forest.

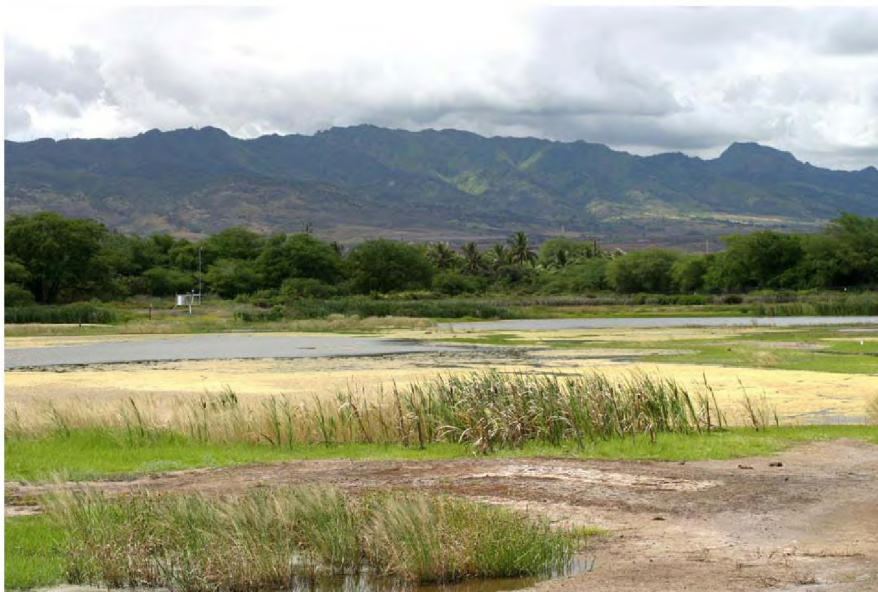
SP1-04 (right): The central drainage ditch at Hono‘uli‘uli Unit of the Pearl Harbor NWR. The shoreline mangal on West Loch is seen across the back.

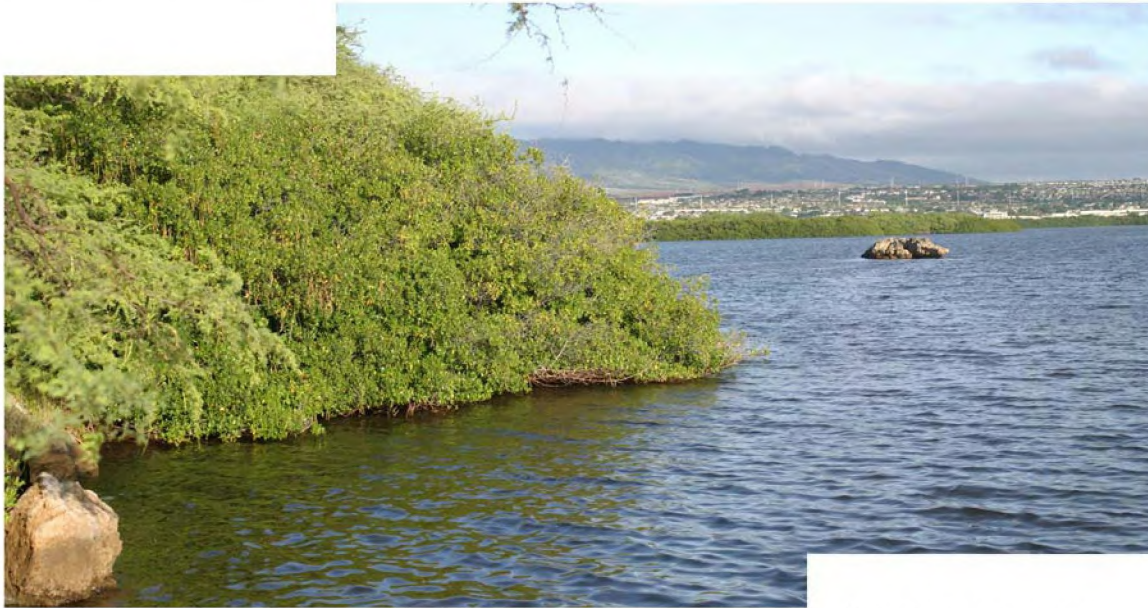
*SP1-06 (above): Nichols Point. Composite photograph showing mangrove growing at base of cliff shore (left) with *kīawe* immediately above. Islet of limestone rock offshore on right is oddly not colonized by mangrove, perhaps lacking any surrounding shallows for propagules to gain purchase.*

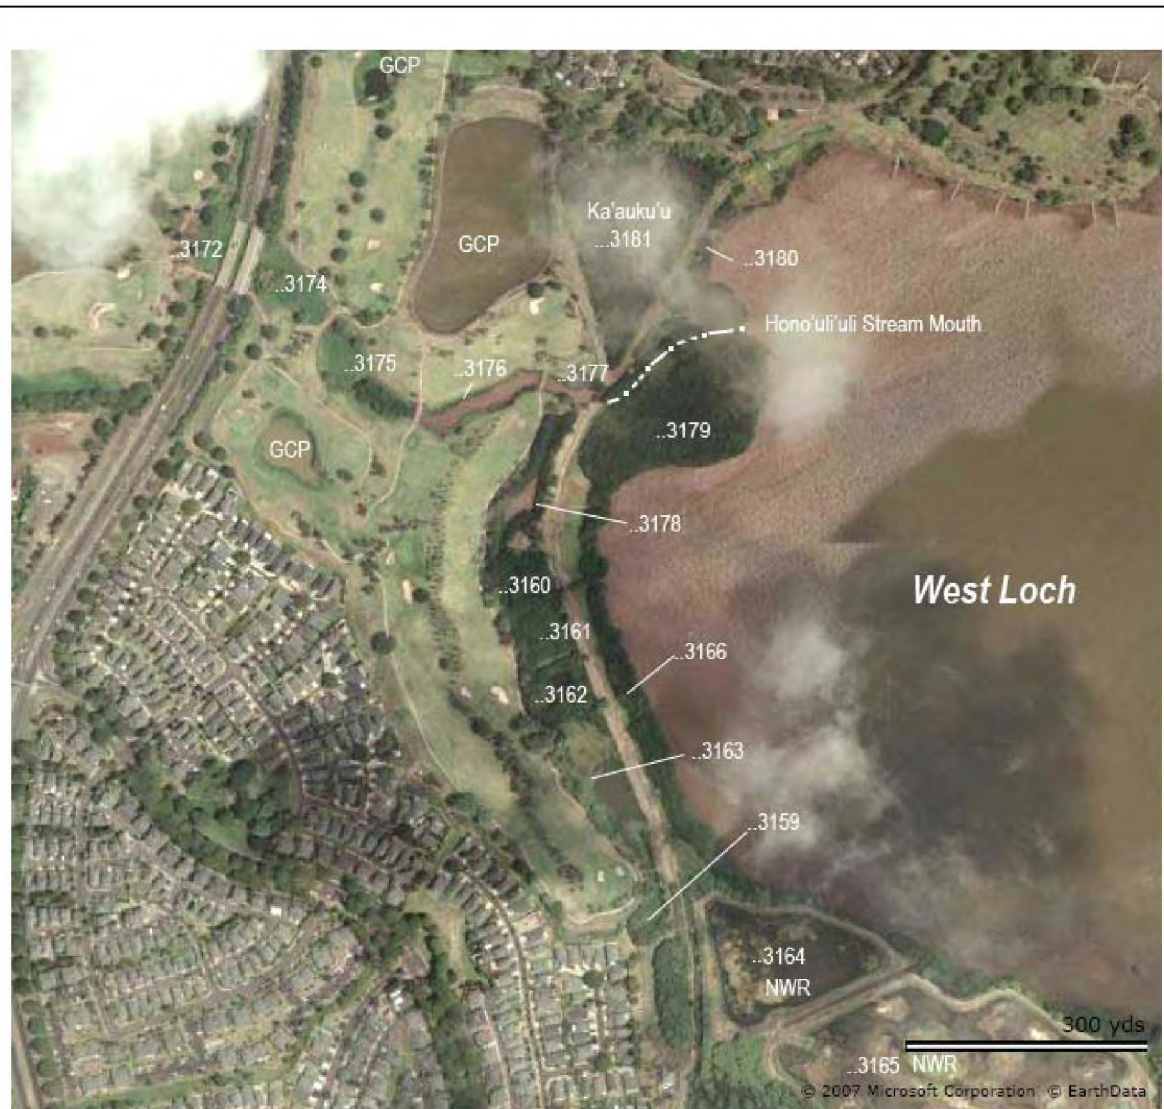
Figure 2-02. West side of West Loch at the mouth of Hono'uli'uli Stream, an area of once extensive wetlands showing locations discussed in text.

GCP = golf course pond.

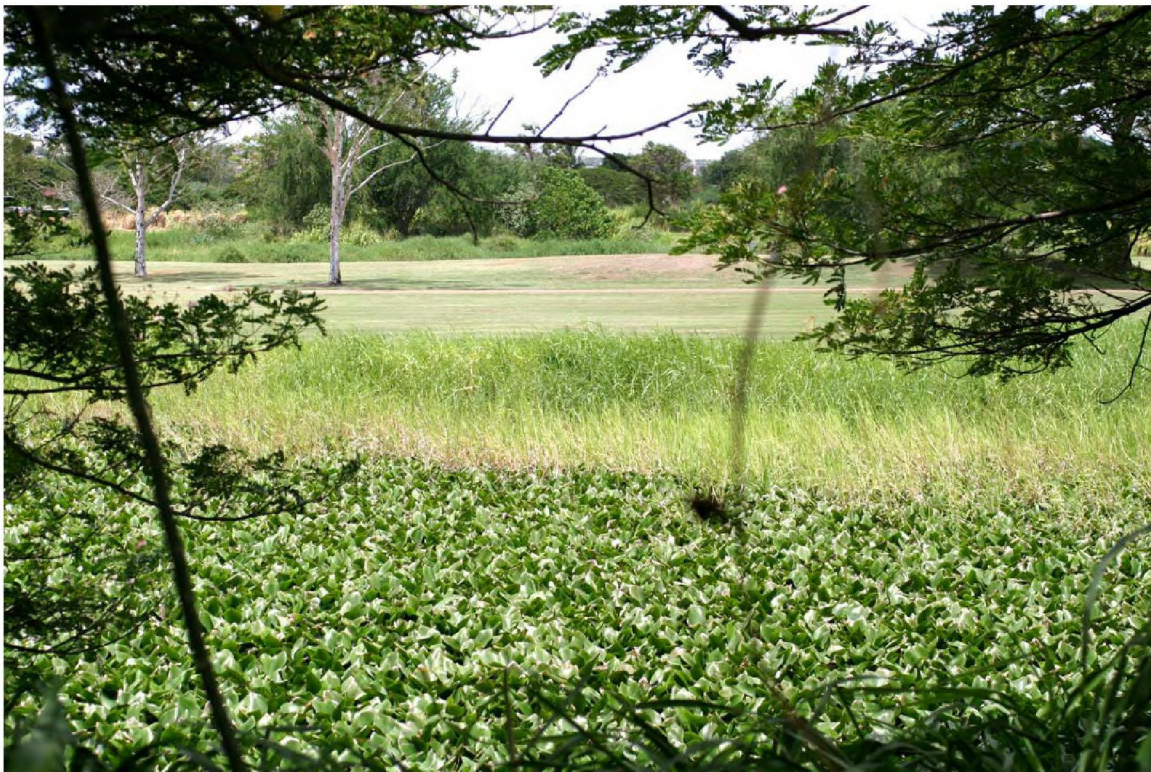
Figure 2-03. The West Loch Golf Course pond (ID ..3168) along the southern edge of the golf course just west of Fort Weaver Road. Water hyacinth dominates the center of this pond feature.

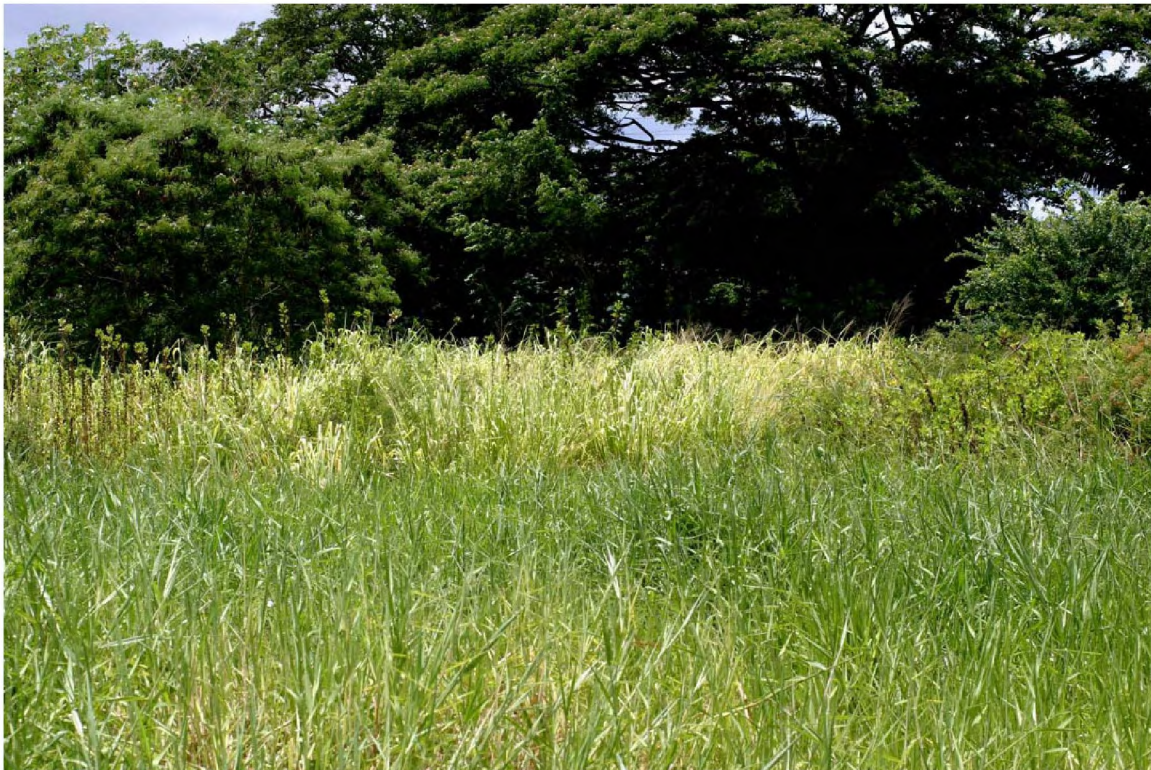
Figure 2-04. All that appears to remain of the wetland behind the former Kahua Meat Co. is a depression completely overgrown with California grass. However, this is not wetland ID ..3167.

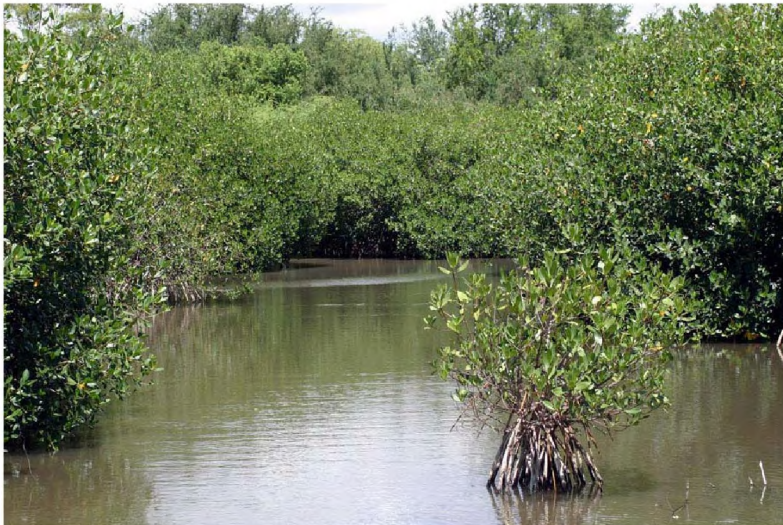
SP2-01 (left): Remnant of open water in mangrove infested Ka'auku'u fishpond (..3181) at West Loch Shoreline Park.

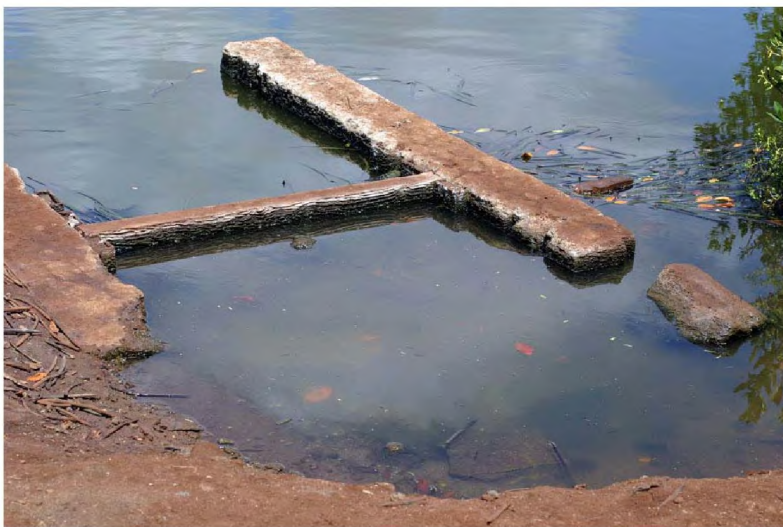
SP2-02 (left): Remains of a concrete *makahā* that once connected Ka'auku'u pond to West Loch via a channel that no longer exists.

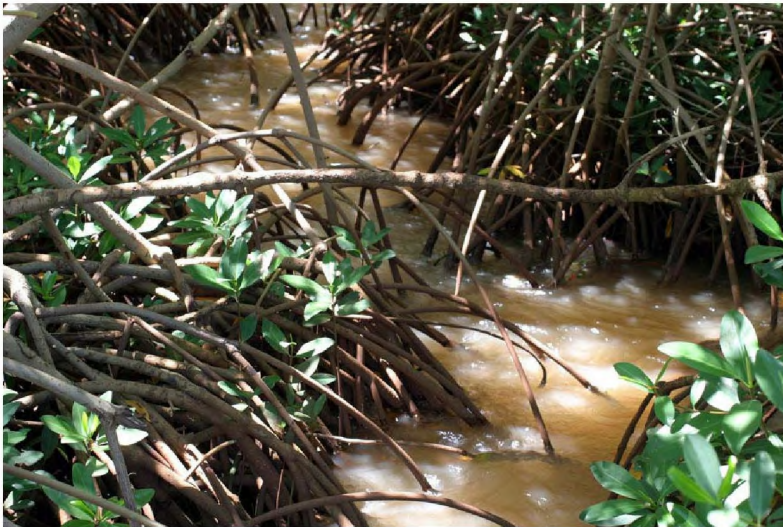
SP2-03 (left). Tidal water rushing through the mangrove-blocked channel connecting the lower end of Hono‘uli‘uli Stream (..3177) and a series of former ponds to the south (..3178 and beyond).

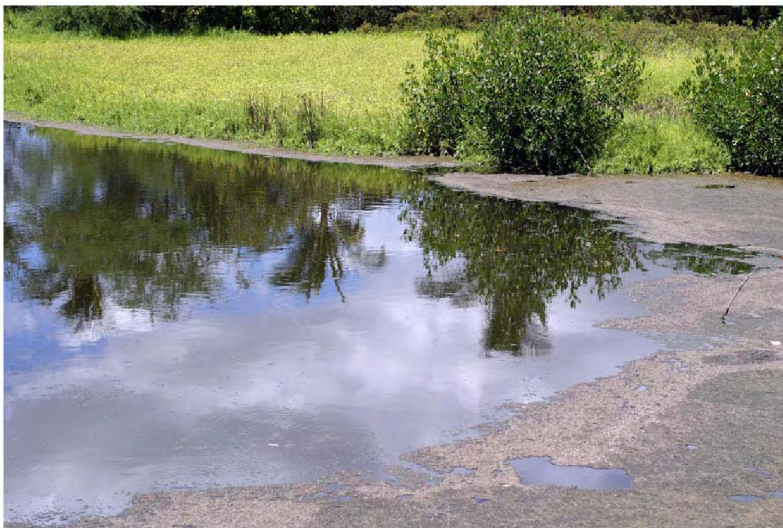
SP2-04 (left): Pond feature at wetland ID ..3163 with pickleweed flat at north end showing invasion underway by mangrove. Gray material along pond shore is an algal scum floating on water surface.

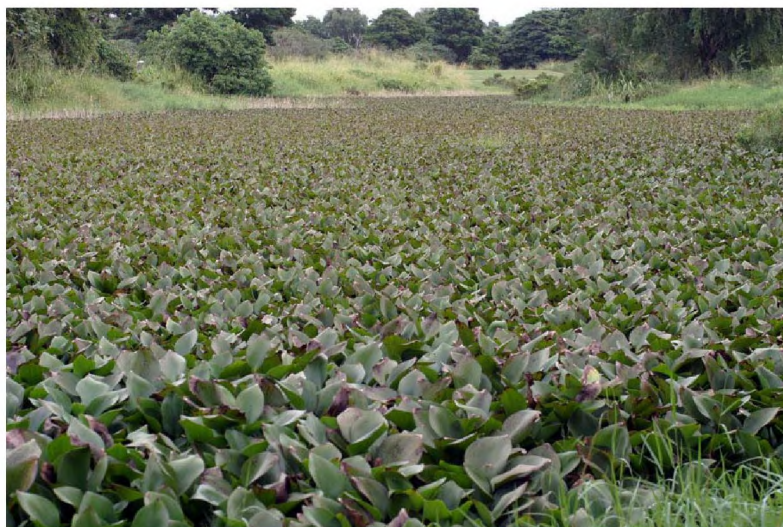
SP2-05 (left): Golf Course Pond (ID ..3168) completely covered by water hyacinth, a floating plant and therefore treated under ACOE rules as open water, not wetland.

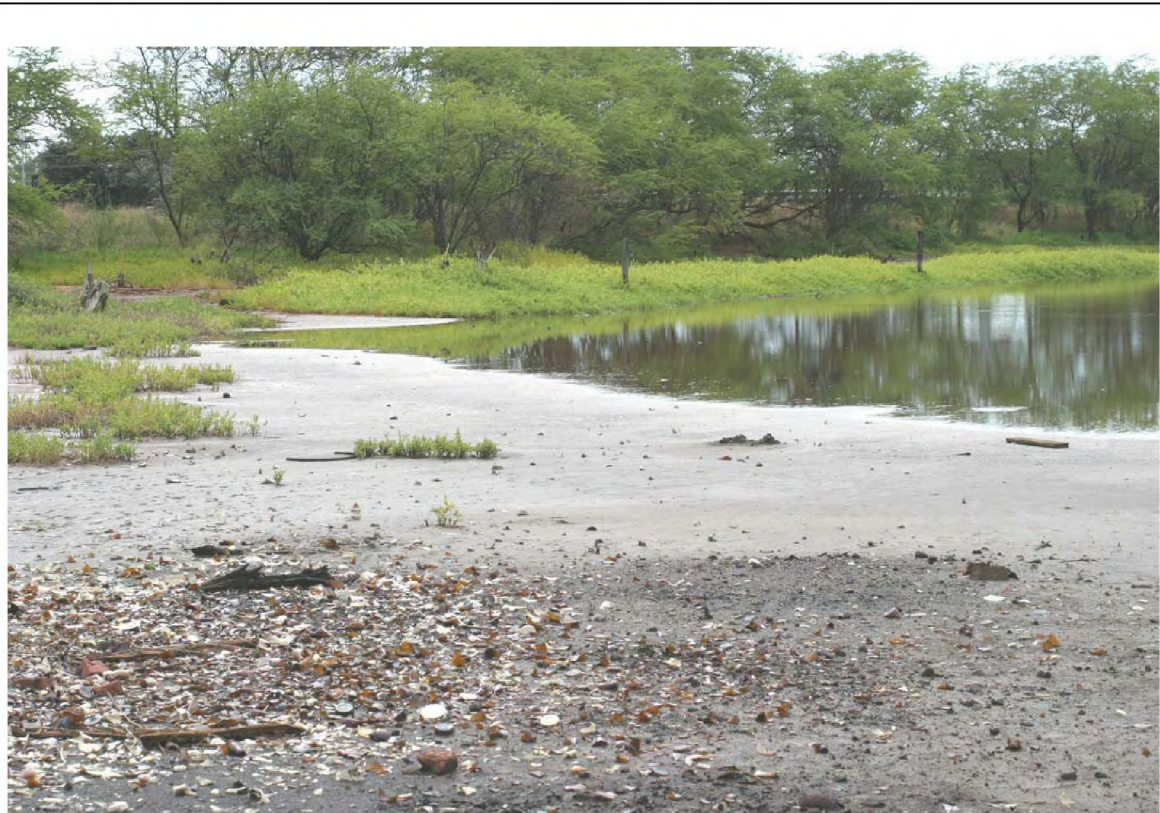
Figure 3-03. Portion of the northern shore of Po'uhala Marsh (*mauka* marsh) with old bottle dump area exposed on mud flat. *Kiawe* trees in background line the levee separating Kapakahi Stream from the marsh, but the trees were removed in 2007.

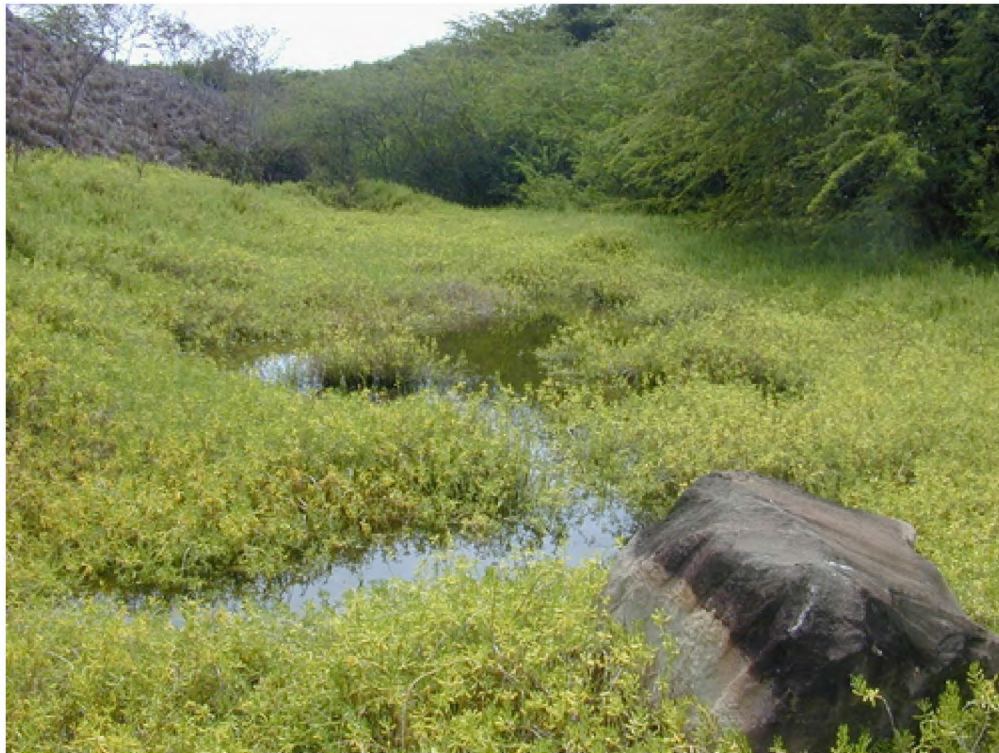
Figure 3-05. An area on the northwest boundary of the ash landfill site near Station 11 (AECOS, 2001a) characterized by a pickleweed (*Batis maritima*) flat with open pools (part of ID ..4244). Old landfill slope is evident in background left.

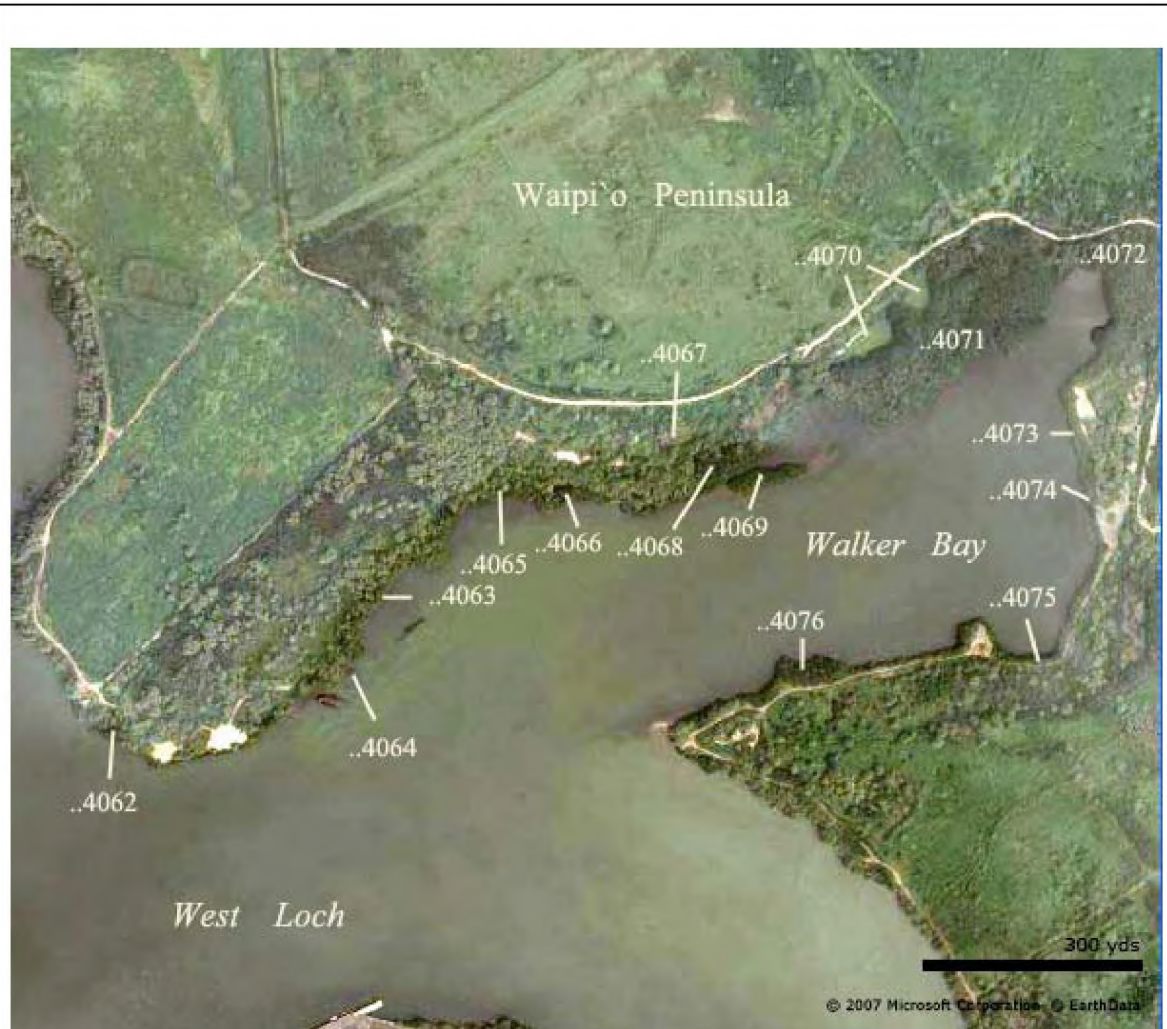
Figure 3-06. Satellite image of Walker Bay showing ACOE (1999) numbered wetlands.

Walker Bay is a narrow re-entrant of West Loch partially dividing the Waipi'o Peninsula. The Bay (Fig. 3-06) is nearly completely surrounded by mangal, only the south shore, where the mangrove border is narrow and broken, affording access to the water without great effort. The northern shore is complicated. Mangal lines the inner, north shore to such an extent (ID ..4068, ..4069, ..4071, and ..4072) that the view of Walker Bay is all but obscured from anywhere on the north side. However, behind this mangal are open areas of *Batis* (Fig. 3-07; ID ..4070) and various drainage (or perhaps detention) features that contain

water in some cases, and are playa-like features in others (Fig. 3-08; ID ..4067 and others not identified in 1999; see photo SP3-02). These depressions, which have high, steep sides, were presumably built to capture and infiltrate runoff from upland sugar cane fields.
